CLOPPERS MILL
COMMUNITY ASSOCIATION

REPLACEMENT RESERVE STUDY
2006

CLOPPERS MILL COMMUNITY ASSOCIATION

Germantown, Maryland

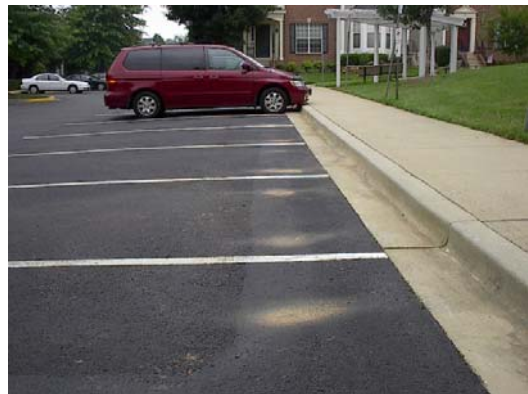
A new seal coat, which is a cost effective way of extending the life of the pavement, was applied in 2004 and is recommended every 5 years - a corresponding line item has been incorporated in the projected expenses of our analysis. In 2005, approximately \$12,000 in asphalt patching was scheduled. Of particular note, was the patching needed to repair the sections of sunken asphalt where the car tires rest in the parking areas.

Sunken Asphalt

In order to maintain the condition of the pavement throughout the community and to insure the longest life of the asphalt, we recommend a systematic and comprehensive maintenance program that includes:

1. Crack Sealing. All cracks should be sealed with an appropriate sealing compound to prevent water infiltration through the asphalt compound into the base. This repair should be done annually. This is an entirely different process from the seal coating discussed below. Crack sealing is normally considered a maintenance activity and is not funded from Reserves. Areas of extensive cracking or deterioration that cannot be made watertight by crack sealing should be cut out and patched.
2. Cleaning. Long-term exposure to oil or gas breaks down asphalt. Because this asphalt pavement is generally not used for long term parking, it is unlikely that frequent cleaning will be necessary. When necessary, spill areas should be cleaned, or if deterioration has penetrated the asphalt, patched. This is a

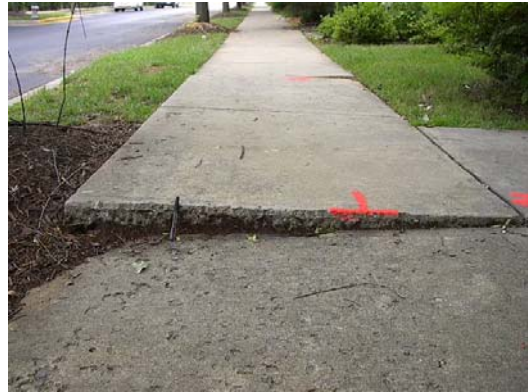
Concrete Sidewalks, Curb and Gutters. All concrete components have been well maintained and are in good condition. Any problems noted are in the form of minor cracks, spalling and settlement that can be repaired by continued periodic replacement of broken sections. In 2005, approximately \$12,000 in concrete repair was scheduled for the community to fix such issues and tripping hazards.

Concrete Tripping Hazard

Because it is highly unlikely that all of the community's concrete components will fail and require replacement in the period of the study, we have programmed funds for the replacement of 30% of the inventory and spread those funds over a 30-year timeframe to reflect the incremental nature of this work. This approach assumes a failure rate of 1% per year and provides funding every three years for the repair of concrete components.

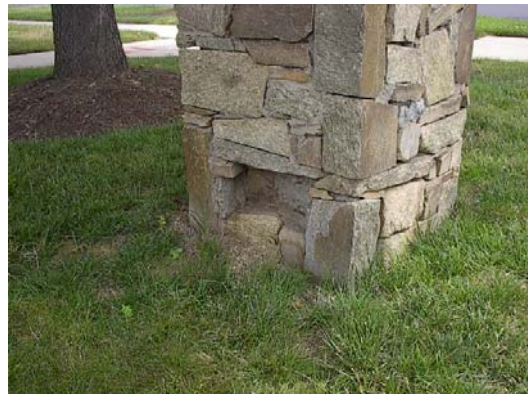
Entrance Monuments. Two stone monuments are located at the intersection of Barleycorn Lane and Cottage Field Lane as entrance monuments to the community. A stone retaining wall can also be found off of Stags Leap Terrace. Because the stonework has a very long life expectancy we have excluded replacement of these walls. We have, however included funding for the periodic tuckpointing of mortar joints as exposure to weather over an extended period of time will wash lime out of the mortar and weaken the joint. Periodic tuckpointing of these joints and replacement of damaged brick is required to extend the life of the wall. Unless the wall is damaged by settlement, this work is typically not required until the wall is approximately 35-40 years old. At that point we expect that approximately 10% of the surface area will require repair and that an additional 10 % will require repair every 10 years thereafter. However, both the wall and the monuments have missing stones and are in need of minor repair.

Damaged Stone Monument

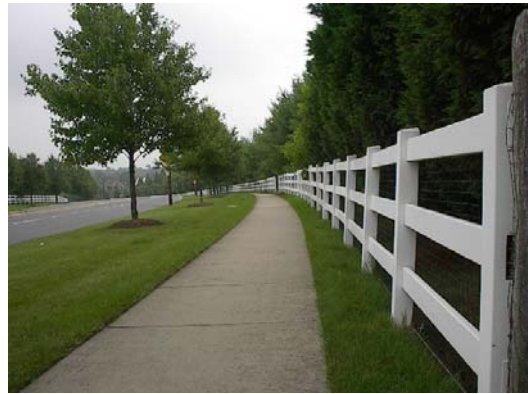
Fencing - Vinyl. The vinyl fencing along Mateny Road and Barleycorn Way is in good condition. Manufacturers of vinyl fencing consider the material to be maintenance-free and often provide lifetime warranties with the purchase of this material. If this conclusion is accepted, there is no need to reserve for this very significant component. If, on the other hand, major work must be done on this component at some point in time because of vandalism, erosion, latent construction defects, etc., the cost will be high. Accordingly, we have included funding for replacement of 10% of this fencing every 10 years, and we have spread these funds over that period to cover the cost of replacing sections of fence that are occasionally damaged.

Vinyl 3-Rail Fence on Barleycorn Way

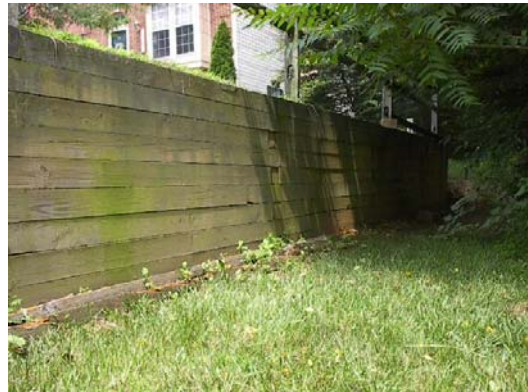
Retaining Walls - Wood. The retaining walls located at the end of Stags Leap Court and by the tot lot off of Stags Leap Terrace are in good condition. We assume that these walls will be replaced on an as necessary basis and have included them in the Analysis as a Cyclic Replacement. We recommend the Association consider one of the segmental retaining wall systems instead of the wood timber construction. These systems are impervious to the decay, which occurs even with the pressure treated wood systems. If over time the wall experiences movement, sections of the walls can be re-stacked at a very small portion of the cost of a new wall. These walls have an initial cost 15 to 30 percent greater than wood walls but once installed, are assumed to have a life equal to the community as a whole and are not included as a component in the Replacement Reserve Analysis.

Retaining Wall

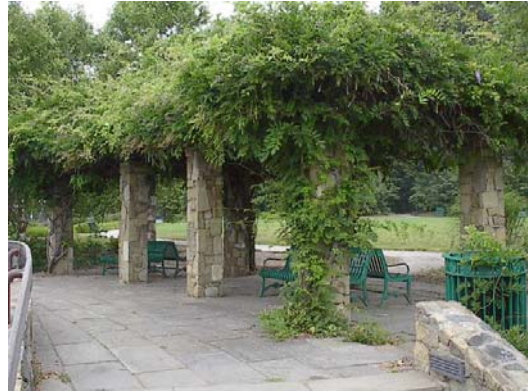
Fountain and Park. The community area off of Stags Leap Terrace includes many reservable items which have been accounted for in the report. The fountain and the wood trellis' have significant amounts of stonework which will require the same tuckpointing described earlier. The flagstone, benches, trash cans, and asphalt trails have also been assessed.

Trellis and Flagstone

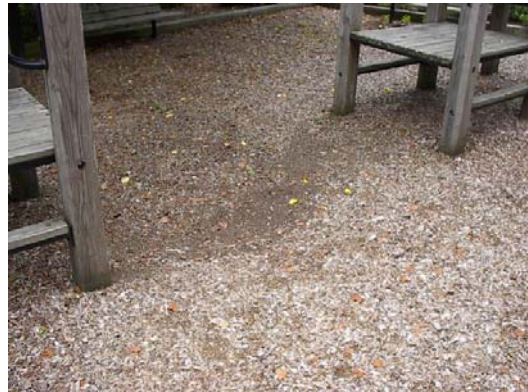
Tot Lots. The two tot lots are in good condition. Both have play structures, miscellaneous play equipment, timber borders and wood chip surfacing. We noted that the playground does not have adequate protective surface under the equipment and around it. The depth of the wood chips under sections of the play equipment has been eroded and is in need of replacement. The safety of each individual piece of playground equipment as well as the layout of the entire play area should be considered when evaluating a playground for safety. The installation and maintenance of protective surfacing under and around all equipment is crucial. Information for playground design and safety can be found in the "Handbook for Public Playground Safety", U.S. Consumer Product Safety Commission, Washington, DC 20207. (Pub. No. 325). The publication can be downloaded at www.cpsc.gov.

Worn Playground Surface

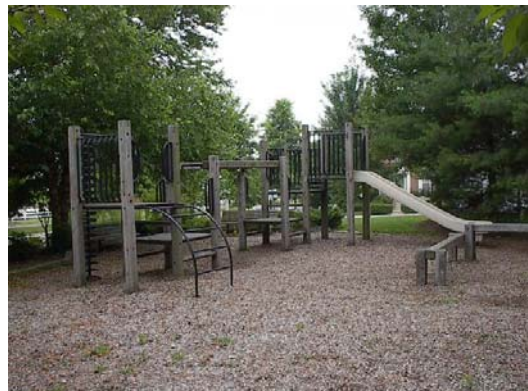
Playground Equipment. Our estimates for playground equipment are based on comparing the existing equipment with equipment of a similar size in manufacturer's catalogs. We use the pricing that is quoted by the manufacturer and add 30% for the disposal of the old equipment and the labor to install the new equipment. Accordingly, we have estimated the cost to replace each set of playground equipment to be in excess of \$10,500. A larger amount can be used if the Association is planning on selecting more elaborate replacements.

Tot Lot by Cottage Field Court

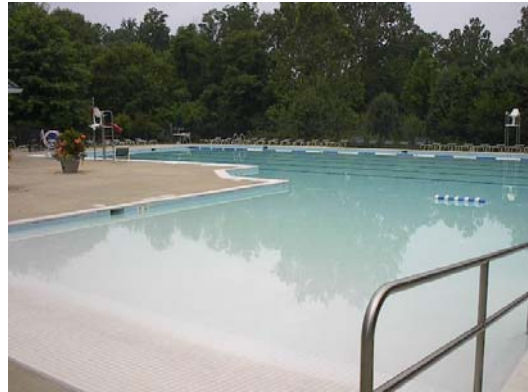
Pool and Pool Deck. The concrete pool deck is in excellent condition. We have included the incremental replacement of the full deck over a 30-year period, because these surfaces suffer more deterioration from harsh pool chemicals and because local health authorities typically require rapid repair of cracks that may harbor bacteria and become hazards to bare feet. A new whitecoat for the pool is scheduled for the next year while the water heater was replaced last year.

Pool

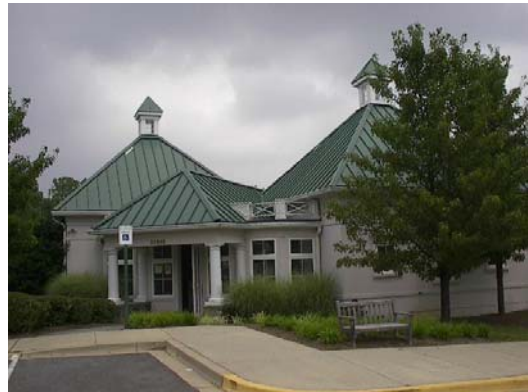
The pool house's primary structural components appear to be in good condition. The performance of the foundation was assessed by examining the exterior perimeter of the building and visible portions of the foundation for signs of differential settlement. No significant misalignment of exterior walls or window/door frames indicating significant differential settlement was observed.

The exterior wall surfaces remain in generally good condition. Windows and doors were operational and weathertight. We did not observe any conditions related to the exterior envelope, which are likely to require major capital expenditures within the near term projection of this report.

Pool House
